# Appendix F

## Testing Program Photos

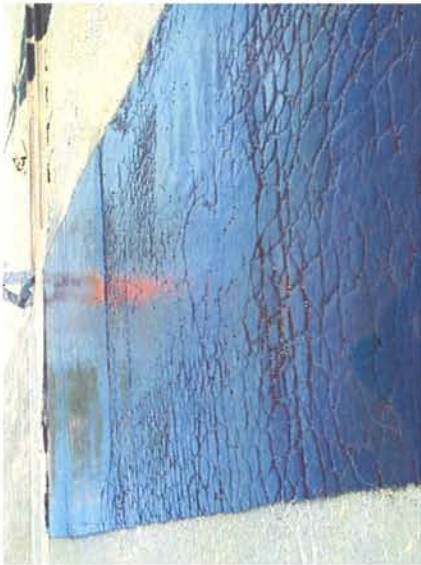
Initial application with the oil truck. PASS® emulsion penetrates the severely cracked surface of the old roadway. Very little preparatory work preceded the application.

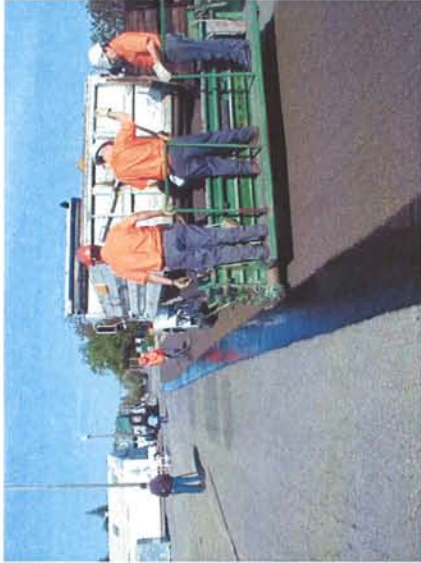
Spreading the first layer of rock "chips".

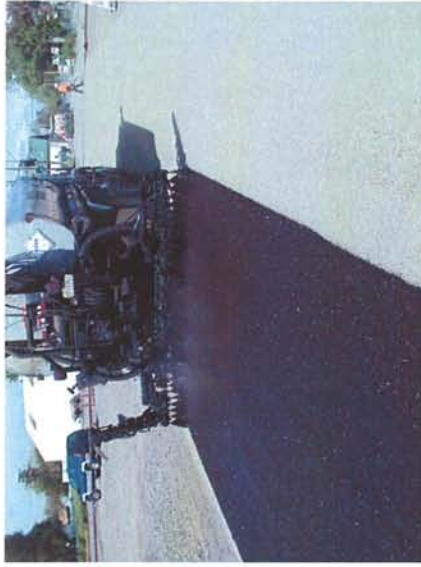
Spray truck applying the second layer of PASS® emulsion over the first layer of rock.

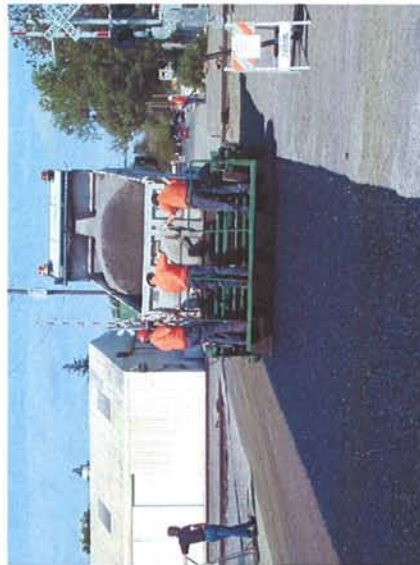
The rock is applied from a spreader box attached to a dump truck driving in reverse.

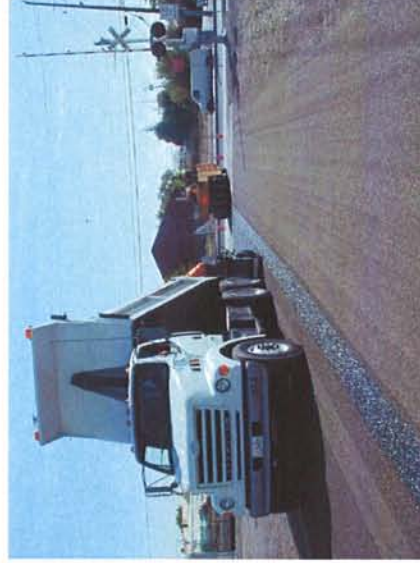
Driving in reverse prevents the truck from driving on the newly sprayed oil

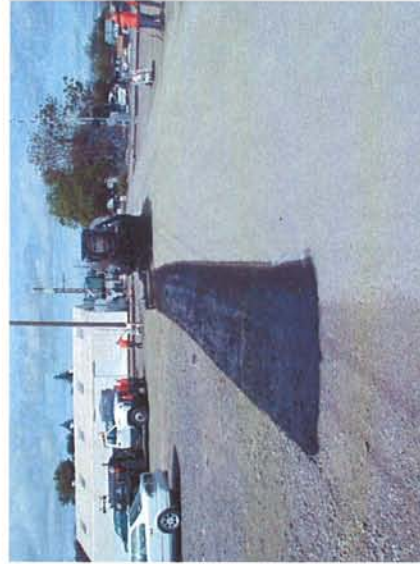
To widen the road and prevent some dust the double chip seal was applied over native soil and rock adjacent to the roadway.

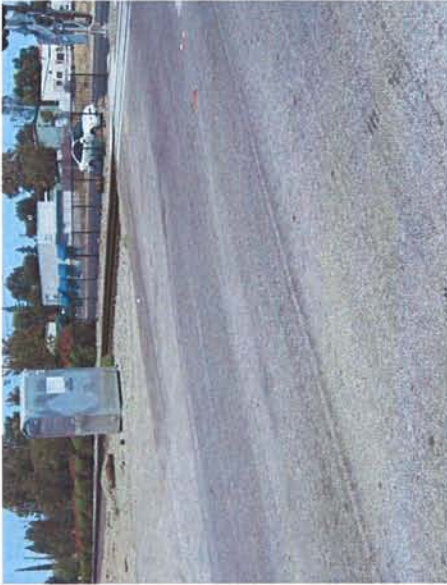
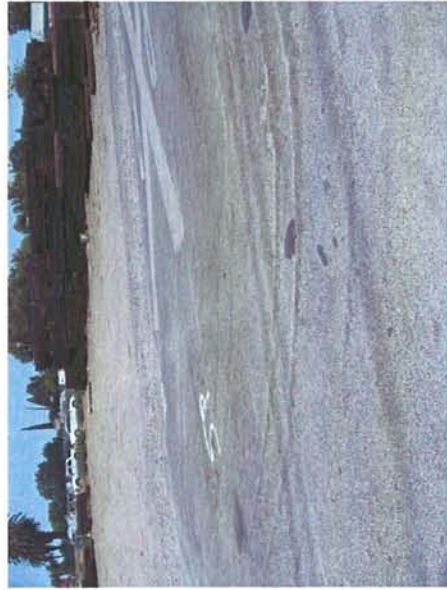
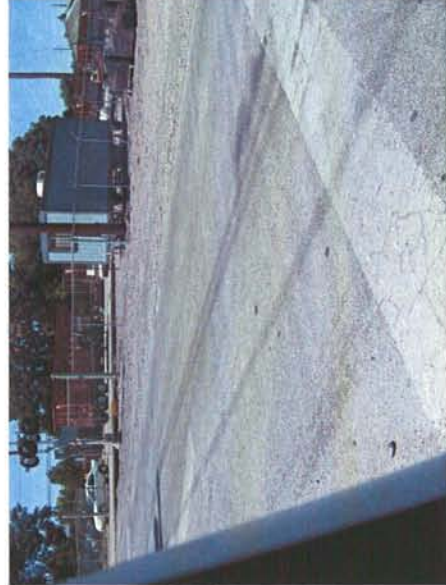
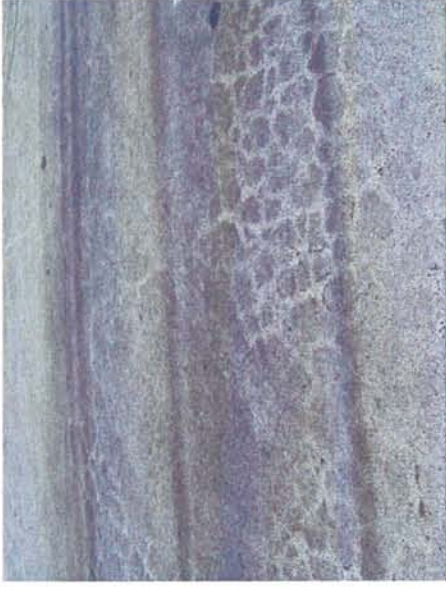
Oak Avenue from Sixth Street to East Street - 2008 Condition

The condition of the roadway in 2007, four years after placement, is much better than was expected. The surface has reflective cracking, however considering the original condition of the road and that very little preparatory work was completed before treatment placement, the road surface is in acceptable condition. Most of the cracks remain sealed and impermeable. Some of the cracks have worked through the treatment to the surface and as a result, the road is likely to be resurfaced in the near future.

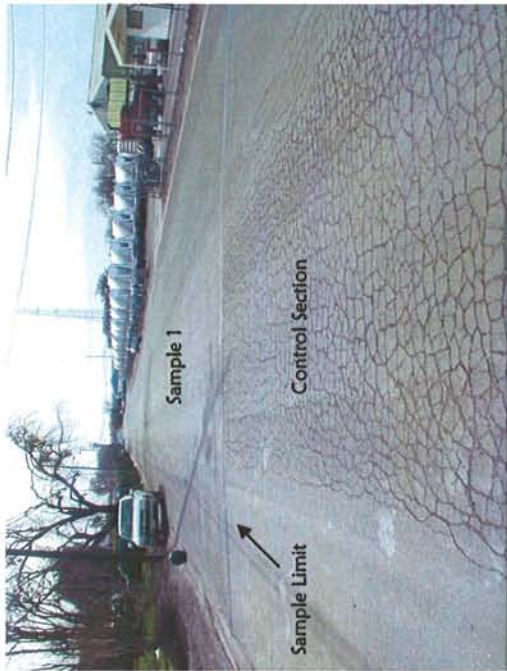
Control section is significantly deteriorated.

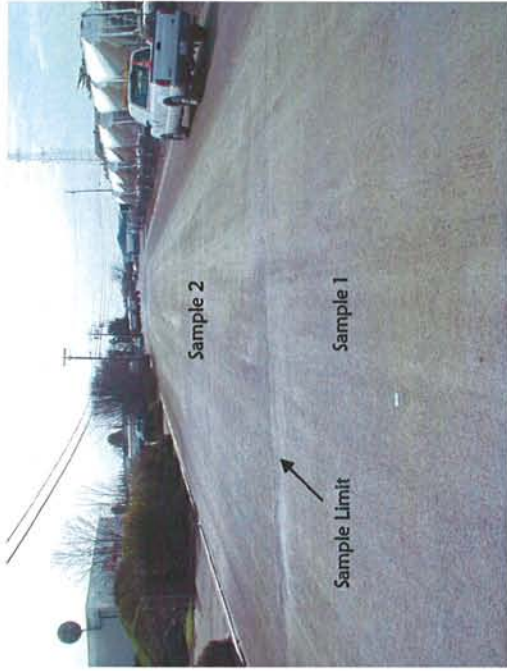
Samples 1 and 2 are substantially without deterioration

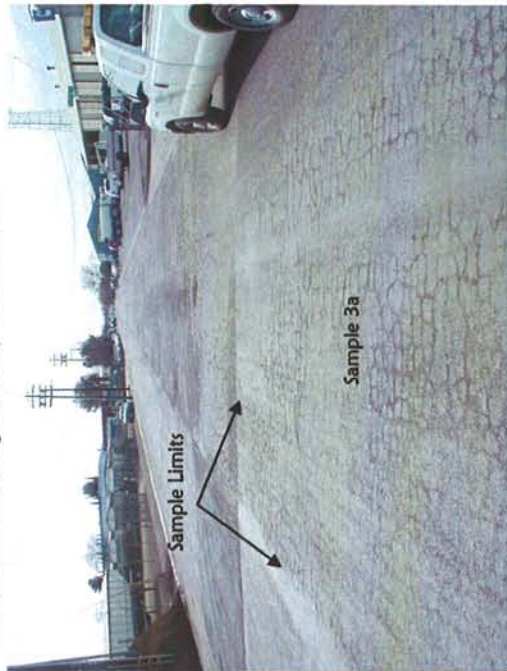
Sample 3a is showing cracking through the new surface. the pavement is in better condition than the control section but is in the worst condition of the sample areas.

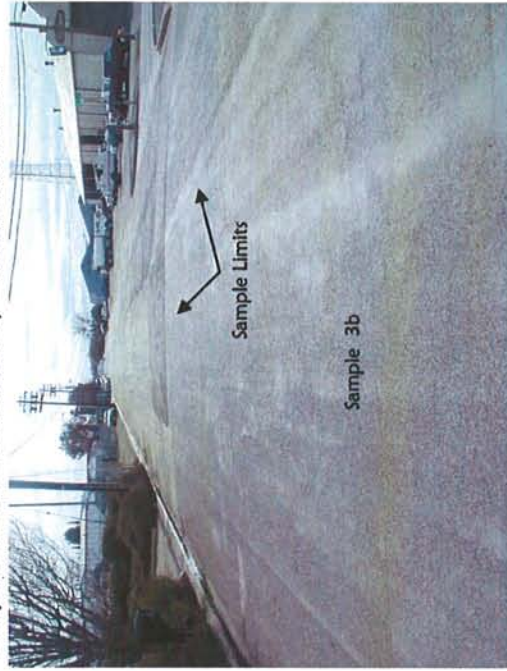
Sample 3b is beginning to show signs of deterioration but remains in better overall condition than the control section and sample 3a.

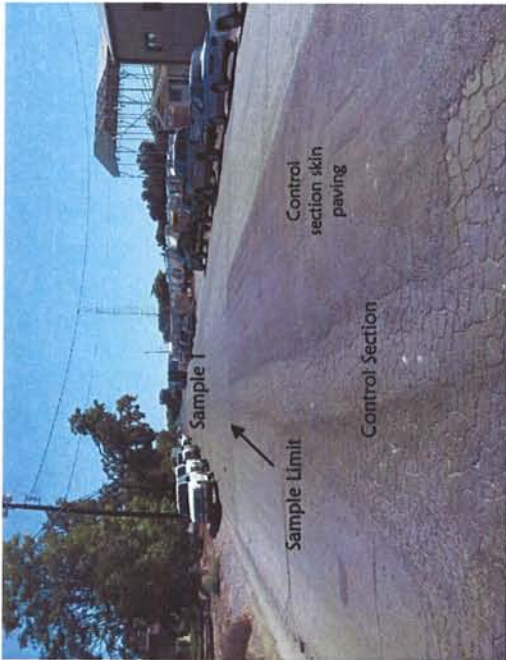
The control section significantly distressed and had to be skin paved to ensure safety and ride-ability.

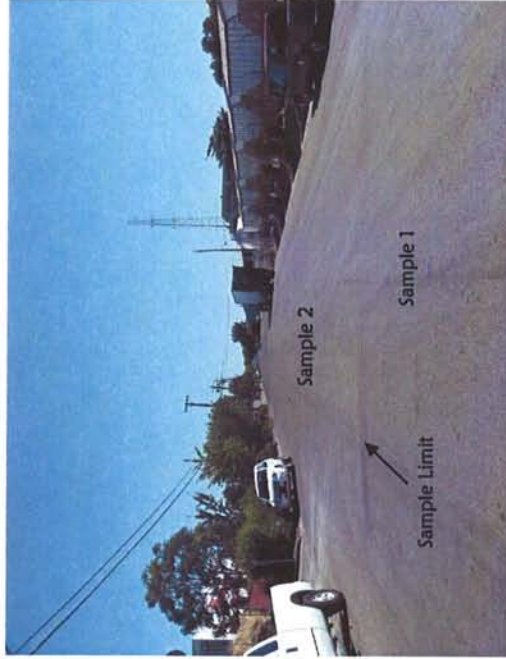
Samples 1 and 2 are still performing well. Initial signs of deterioration are weathering and very slight surface cracking.

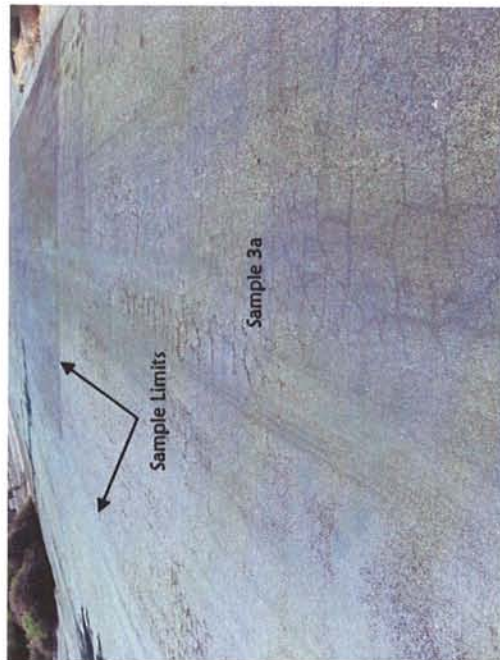
Sample 3a remains better than the control section but has areas of significant deterioration where water is penetrating the surface. The area may be sealed again in the near future.

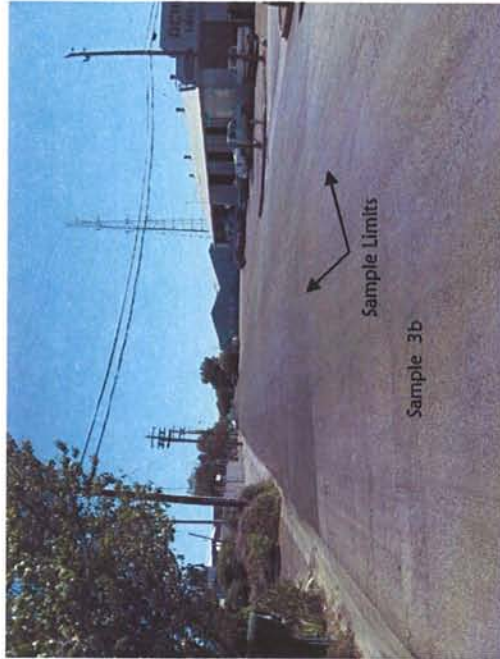
Sample 3b is showing more reflective cracking yet remains in fair condition. The surface remains mostly proof.

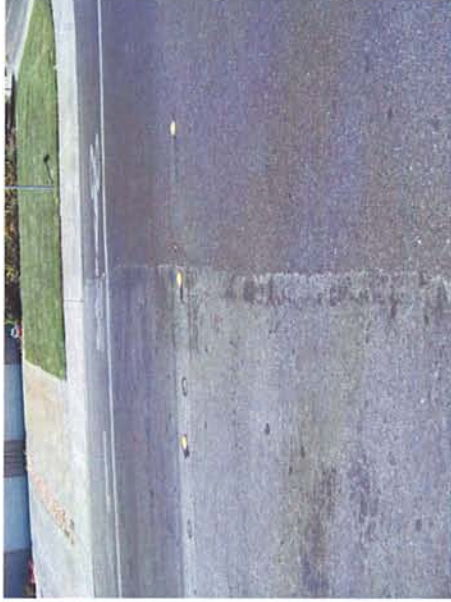
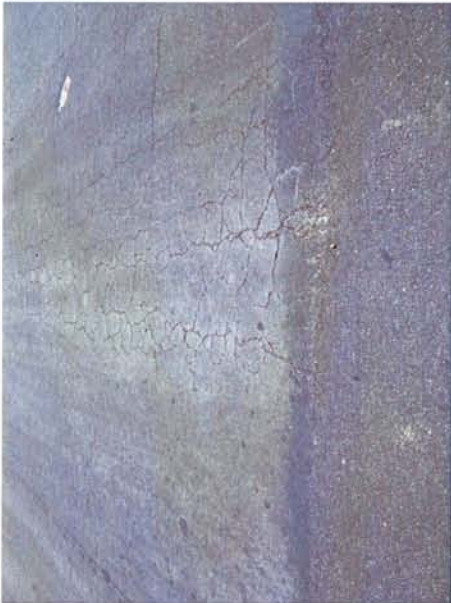
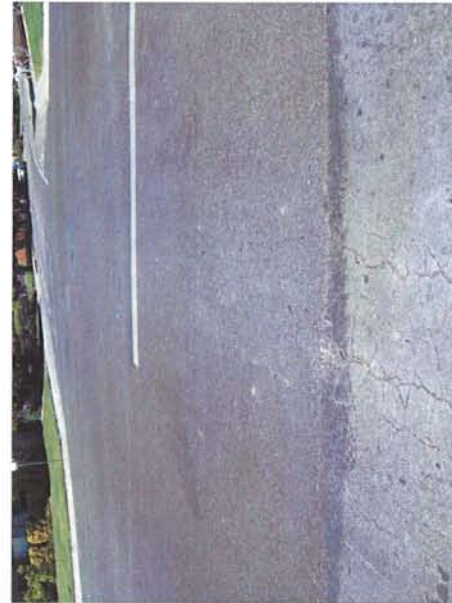
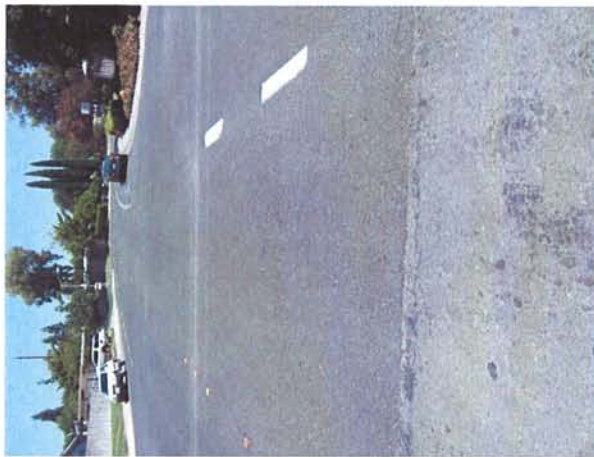
El Dorado from Ashley to Inverness - 2008 Condition

The rubberized overlay has prevented pre-existing cracks from reflecting through to the new surface. The surface of the overlay is in very good condition, showing that the RAC material performs at least as well as conventional AC.

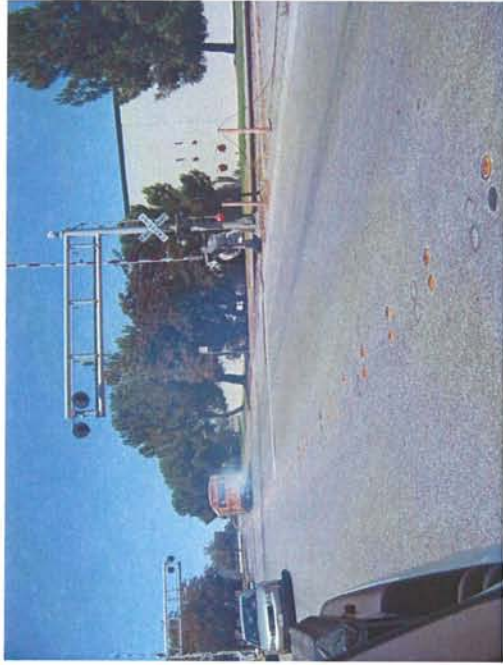
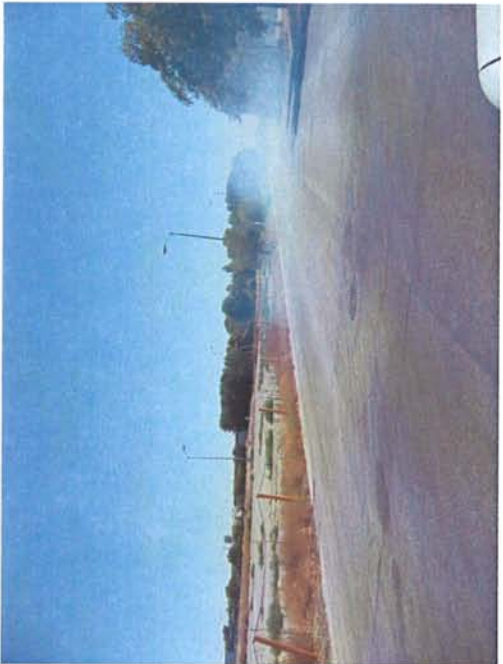
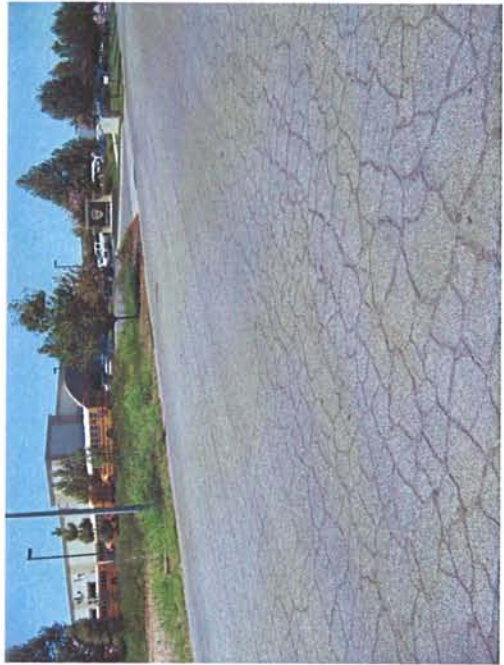
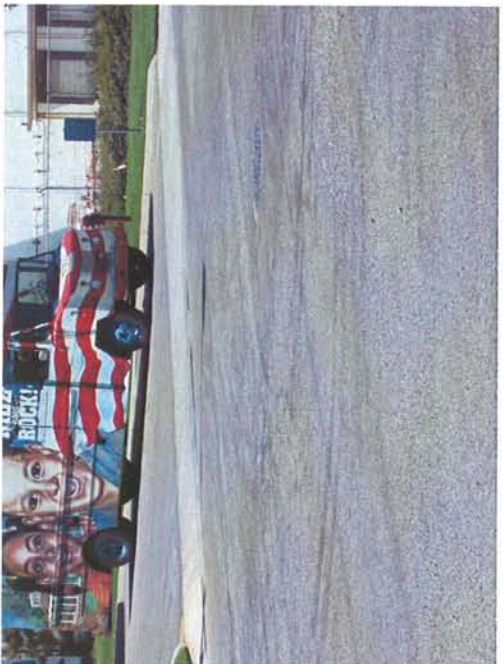
Santa Anita Court - 2008 Condition

The condition of Santa Anita just two years after the double chip seal was placed is much worse than was expected. There are significant surface cracks and alligator cracking.
